LINCOLN ARCHAEOLOGICAL STUDIES No. 4

The Archaeology of the Lower City and Adjacent Suburbs

Kate Steane

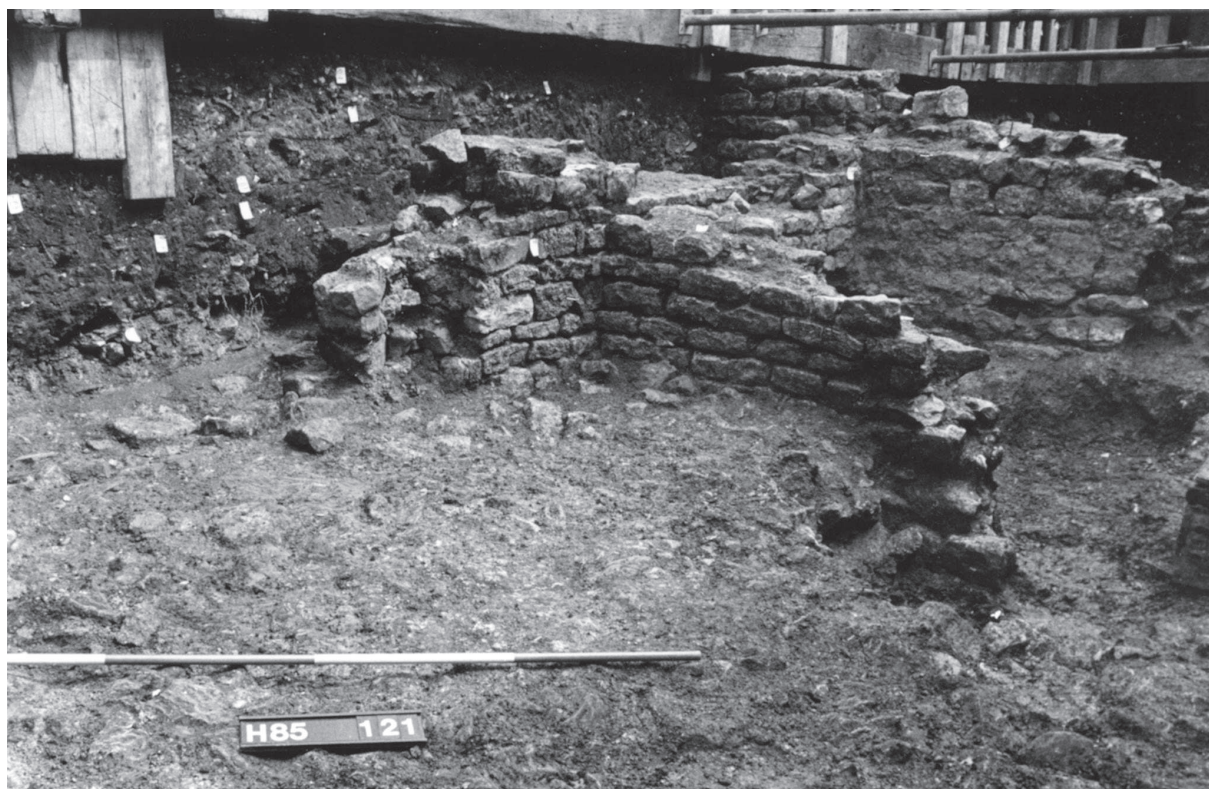
Fig. 8.52. The north wall cg76 of room 2B, abutted by wall cg24 to form the courtyard 2D and room 2E: LUB 9. Looking north-east.

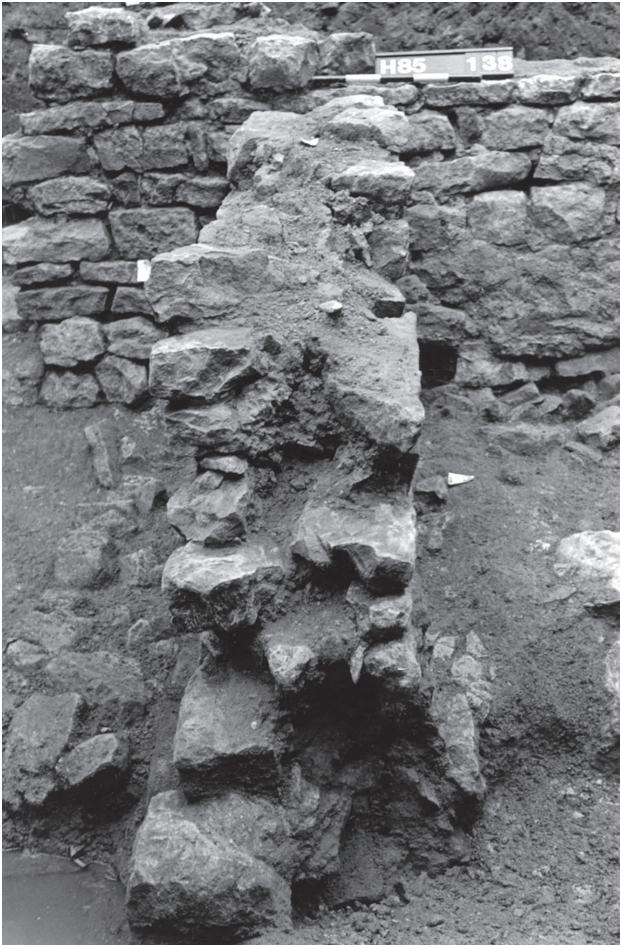
Fig. 8.53. Looking north along wall cg24 towards wall cg76: LUB 9.

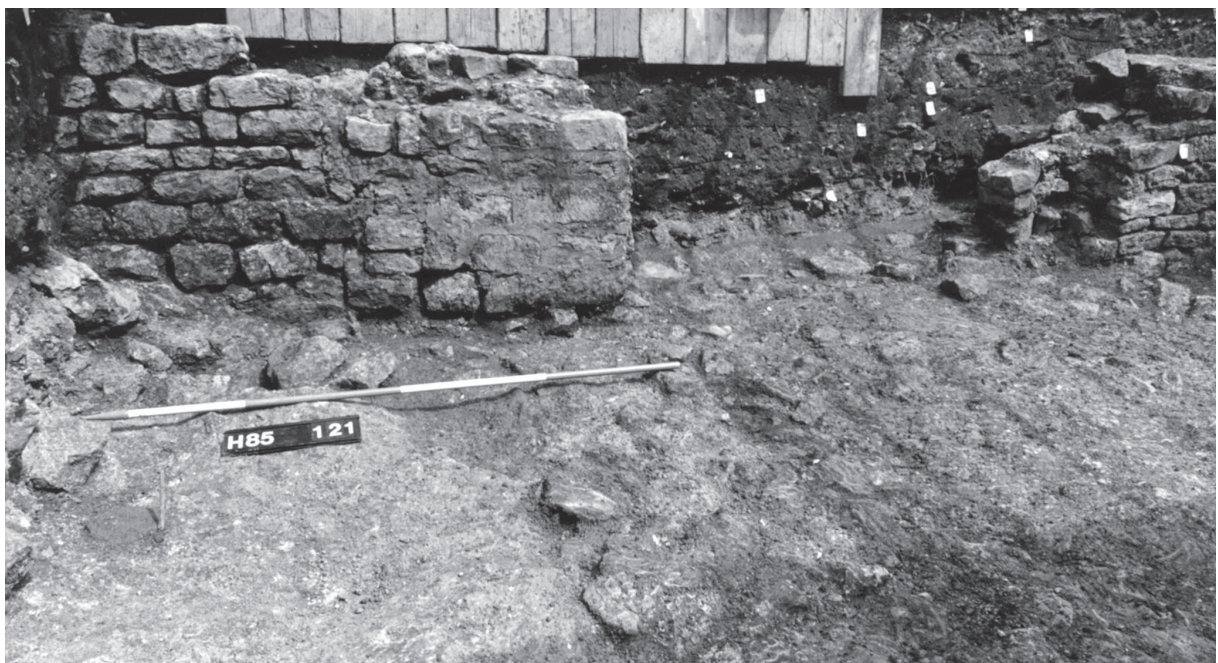
Fig. 8.54. Looking north-north-east at the modified doorway cg93 between 2A and 2D, with the remains of rubble cg98 to the left: LUBs 12 and 16.

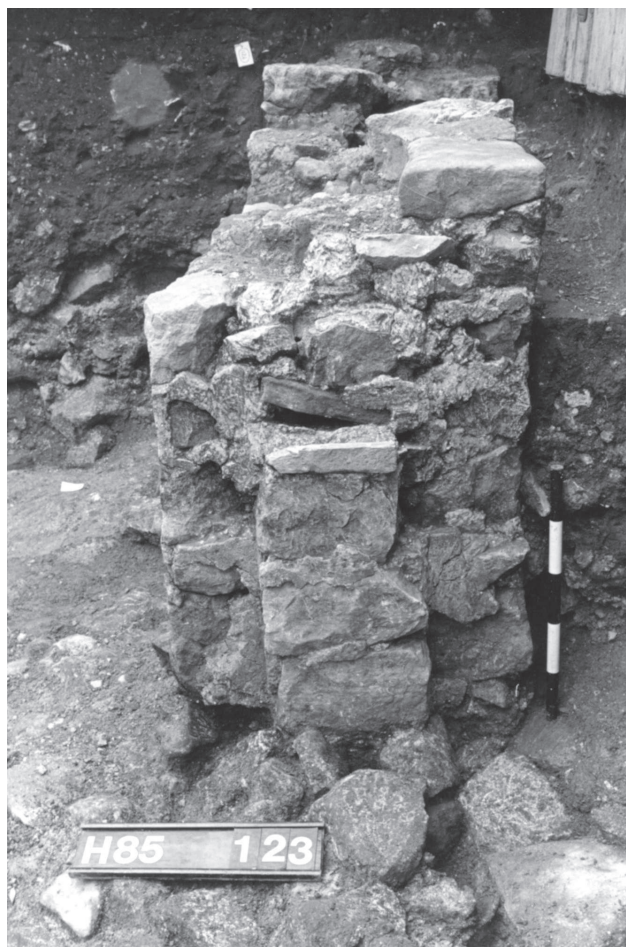
Fig. 8.55. Detail of rebate cg93: LUB 12. Looking west.

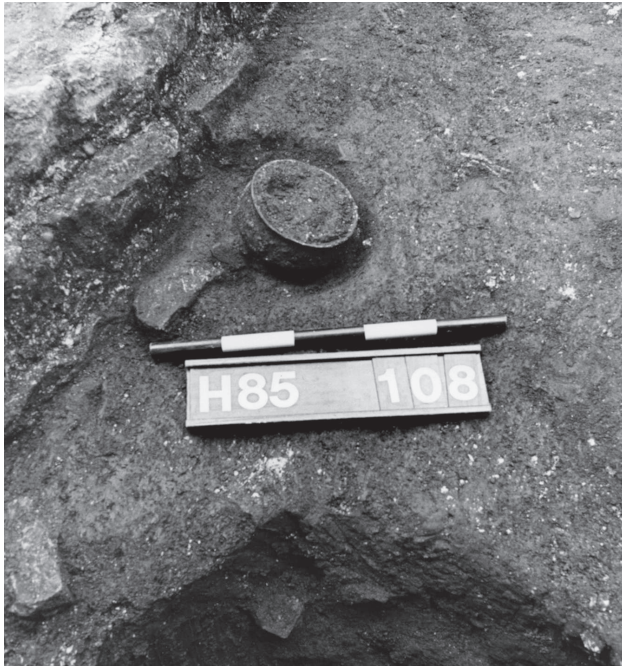
Fig. 8.57. Copper alloy bowl in small pit cg367: LUB 17. Looking north-west.

A few nebulous features appear to have been cut through the dumps but their edges could not be defined during excavation; one small pit cg367, immediately to the east of the main north–south wall cg76 (**LUB 5**) and to the west of the line of the culvert cg536 (**LUB 8**), contained a copper alloy bowl (1167) <1405>, presumably a deliberate deposit (Fig. 8.57; see p. 288). Only the out-turned rim and part of the vessel wall remained intact, albeit in highly degraded condition (Fig. 8.58); there were no other associated finds.

A copper alloy bowl was buried within a small pit cg367 (LUB 17) just large enough to accommodate it; it was highly degraded when found, and suffered further damage when removed. The excavation record notes that the lip of the vessel protruded through cg64, suggesting that the pit had cut through this initial dump over the area of Structure 2C. Approximately 80mm tall and with an out-turned

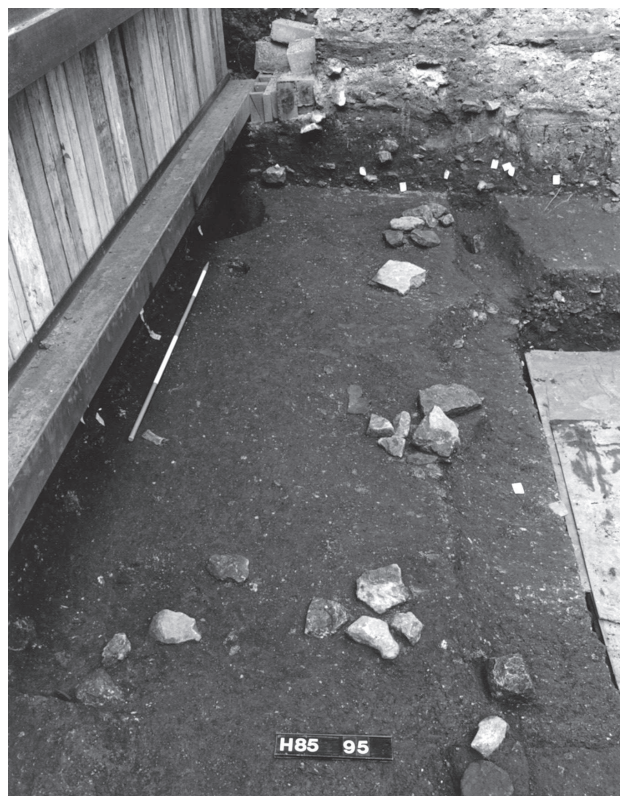
Fig. 8.59. Looking north at the post-pads cg207 of Structure 4.2: LUB 22.

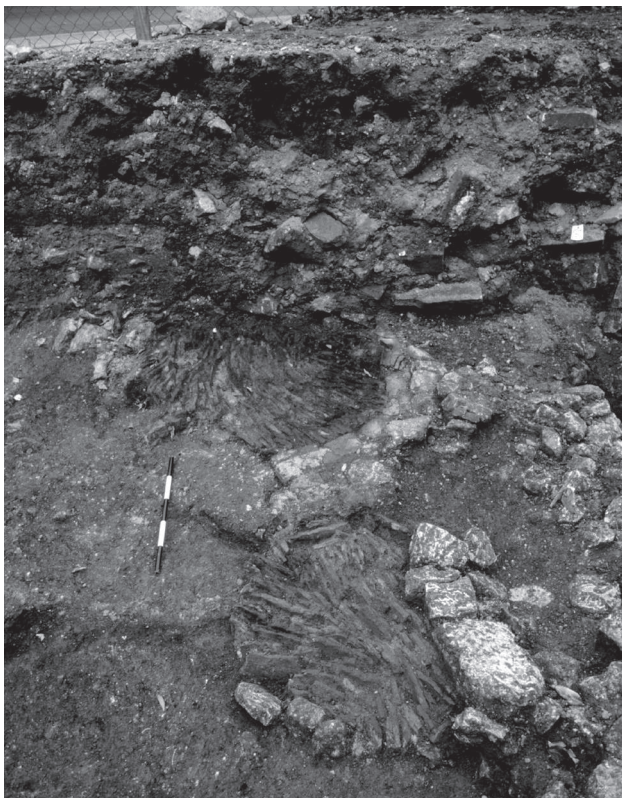
Fig. 8.60. Looking west at ovens cg320 and cg530 in Structure 10A.2: LUB 38.

silty clay cg290, over which were sandy deposits, probably occupation layers, cg291. This was in turn sealed by a loam deposit cg292, probably make-up for clay floor cg293, and then by a silty loam occupation layer cg319. Into this layer were cut a posthole cg362 adjacent to wall cg294 (LUB 36), a small pit cg361 and two ovens, with bases constructed from tiles set vertically: cg320 (centrally placed) and cg530 to its west (Fig 8.60).

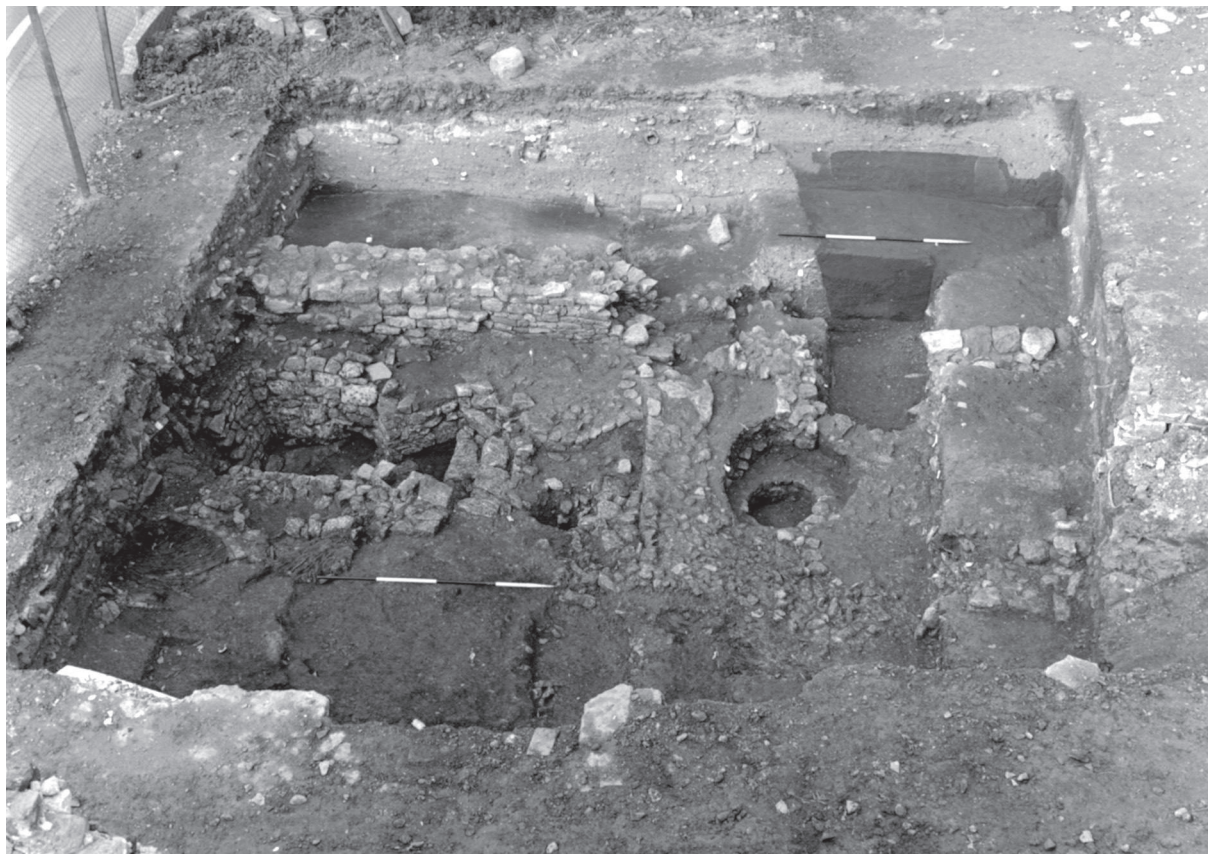
Fig. 8.63. Structure 11, with oven cg322 mid left and east–west wall cg355 behind; traces of north–south wall cg323 are visible in the centre, immediately to the left of the later well cg349: LUBs 45, 46 and 53. Looking north.

The late medieval successor to Structure 10, Structure 11 (LUBs 45–7), probably had an added hall (Structure 11C) at the rear. All its elements had been demolished by the early–mid 16th century. Subsequently, the whole of the main excavation trench was for a while occupied by Structure 12 (LUBs 50 and 51; Figs 8.30–31) which also fronted Hungate. This building appeared to follow a different east–west boundary to the rear of the Hungate frontage from its predecessor, Structure 11. Only in the 1986 trench were there hints of the rear of properties facing on to High Street. A post-medieval building (Structure 13) fronting Hungate was constructed in the south-western part of the main trench (LUB 54), while the rest of the site to north and east was an open area containing various features (LUB 53). The parliamentary survey of 1649 indicates that by then the property occupied by Garmston House (now 262–3 High Street) extended all the way back to Hungate and incorporated a stable of ‘rough stone

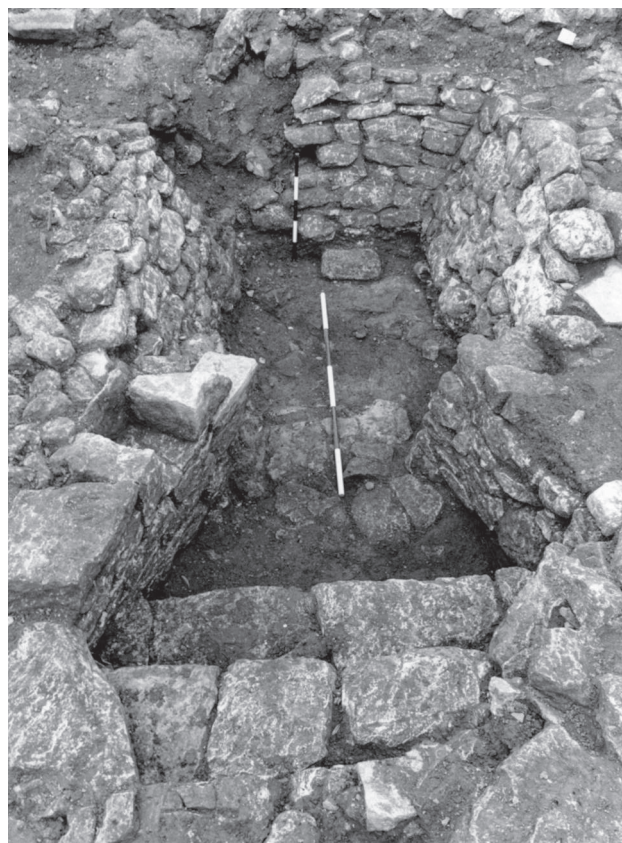
Fig. 8.64 (right). Detailed view of oven cg322: LUB 45. Looking west.

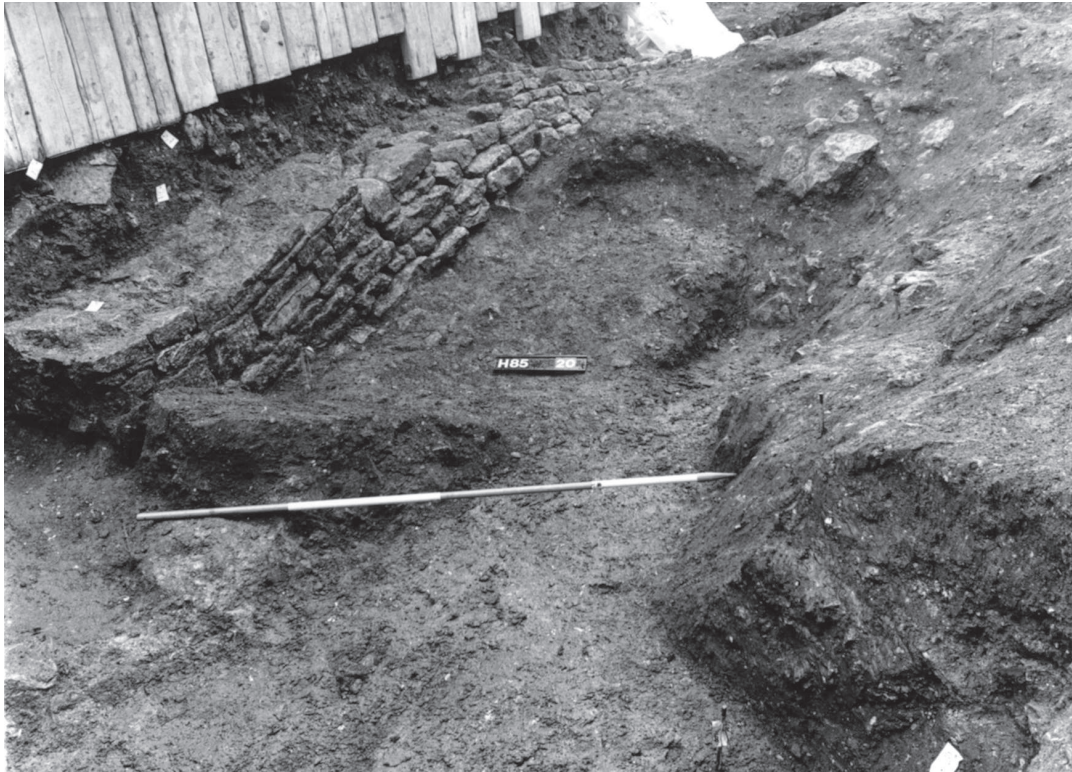
Fig. 8.65. Looking south-west at wall cg192 of Structure 11C: LUB 47.

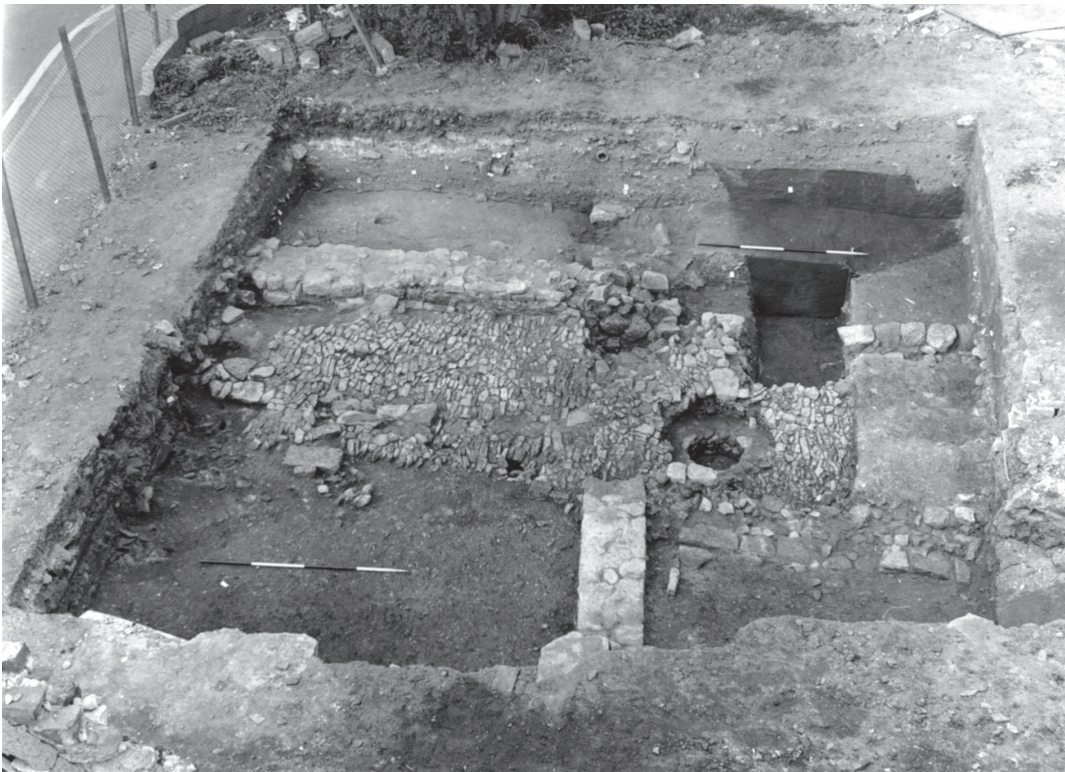
Fig. 8.66. The remains of Structure 12.1 as excavated in 1983. The east–west wall cg355 (centre left) was reused from Structure 11, and wall cg245 (centre right) extended into the east section (cf Fig 8.67); cobbled surface cg246 lay to their south: LUBs 46 and 50. The well cg349 and north–south wall cg335 in the foreground belonged to later phases – the latter to Structure 13.1: LUBs 53 and 54. Looking north.

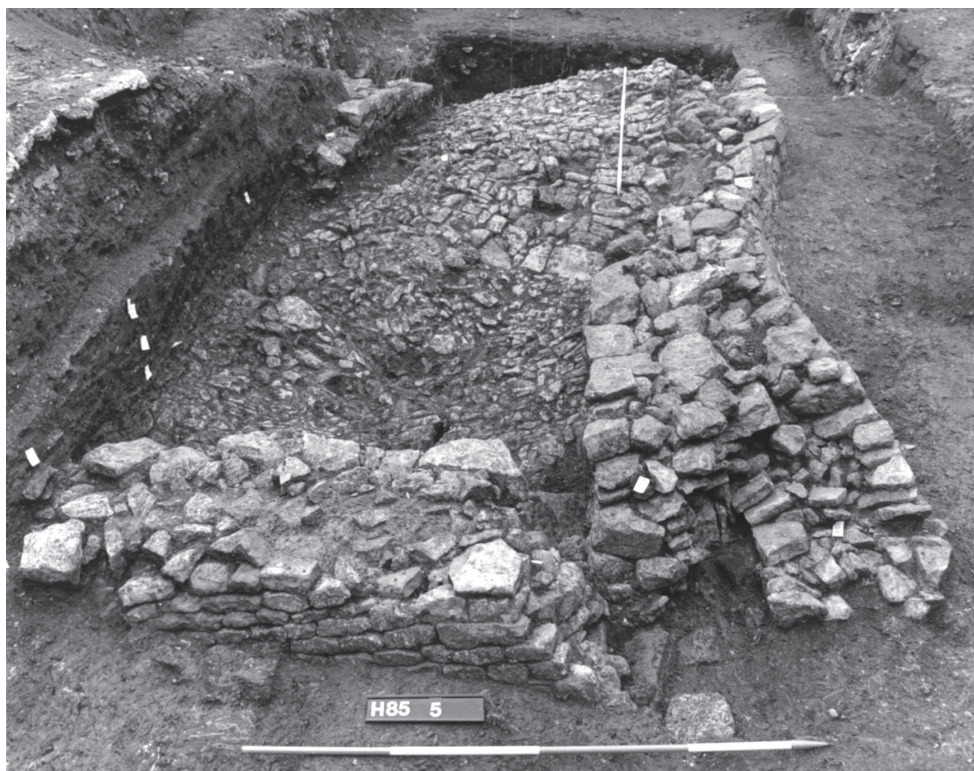
Fig. 8.67. Structure 12.1: walls cg245 and cobbled surface cg246 as revealed in 1985, to the east of those fragments excavated in 1983 (cf Fig. 8.66): LUB 50. Looking west.

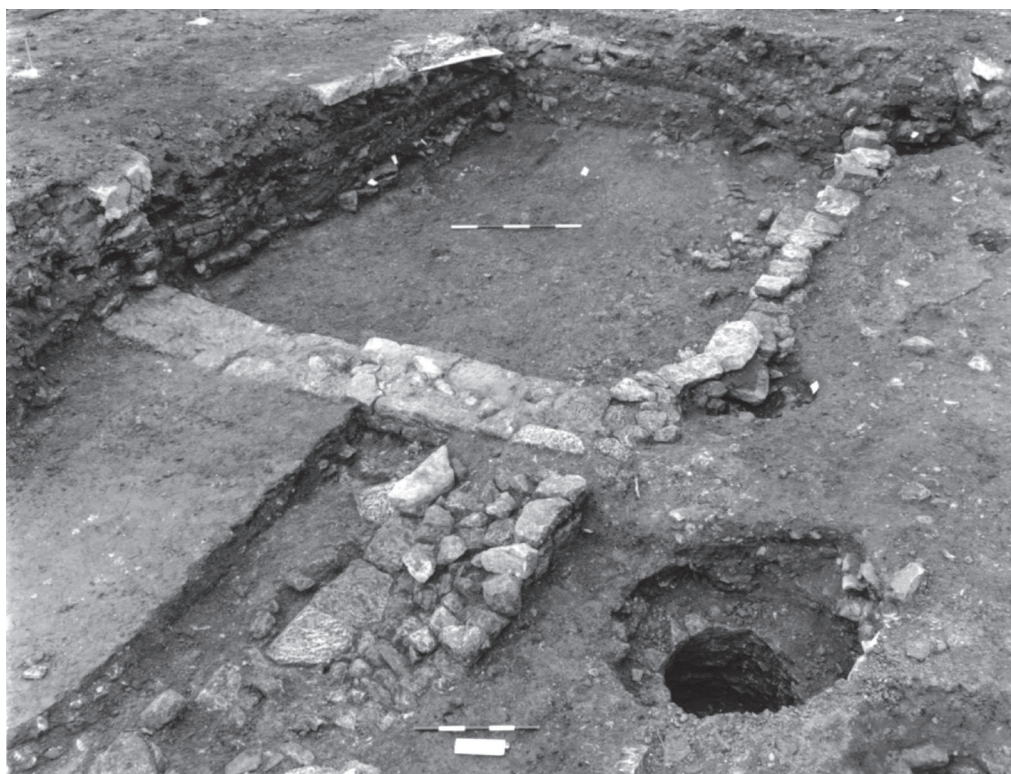
Fig. 8.68. Wall cg249 of Structure 12.2 (foreground), cut by the walls cg335 of Structure 13 (background); well cg349 to its right: LUBs 51, 53 and 54. Looking south-west.

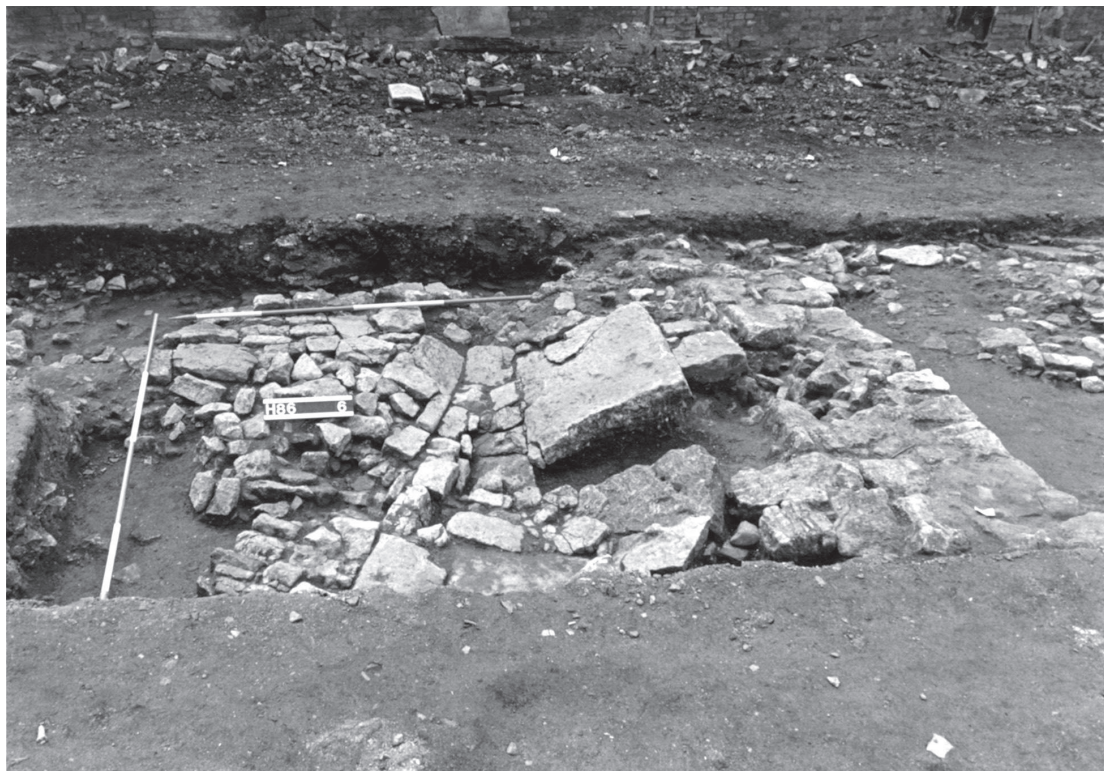
Fig. 8.69. Looking south at drain cg533 and surface related to Structure 14, whose west wall cg500 is visible (right): LUB 60.

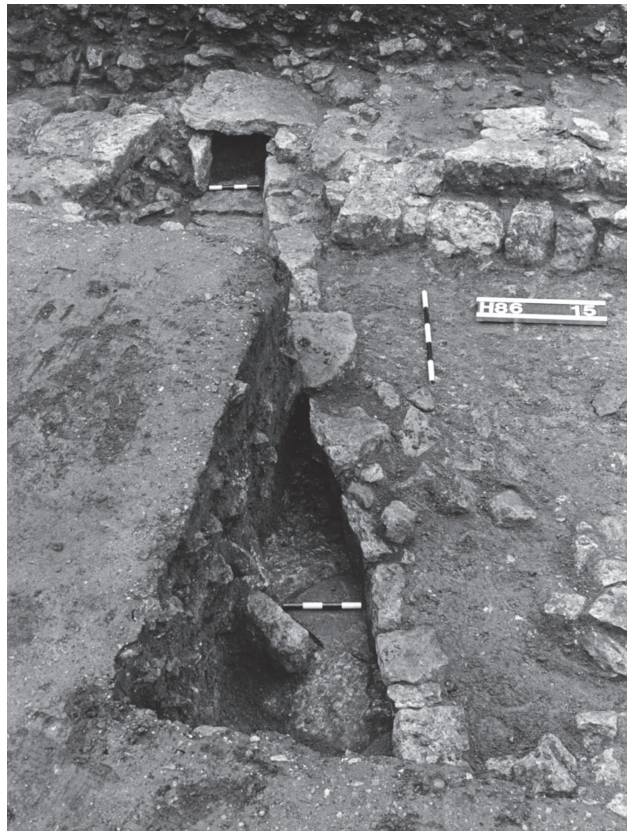
Fig. 8.70. Drain cg502 partially excavated: LUB 63. Looking south.

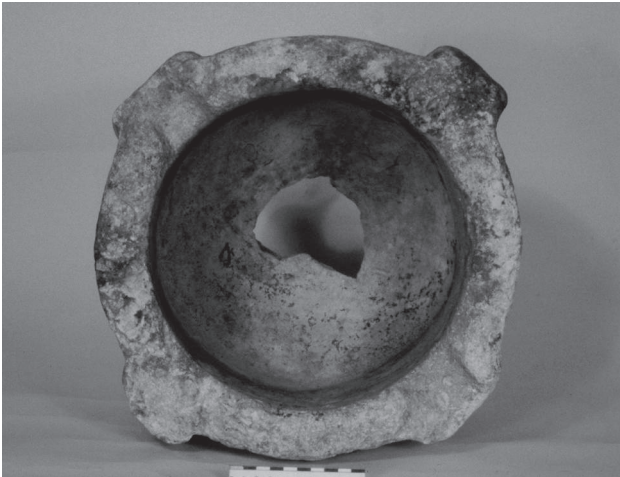
Fig. 8.71. Complete mortar in Lincolnshire limestone.

A noticeable proportion of the registered finds from medieval and post-medieval levels comprised quern and mortar fragments, which occurred in higher numbers here than on any other Lower City site. They were most apparent within levels associated with the construction (LUB 50: incorporated within make-up cg202 and cobbled surface cg246) and demolition levels (LUB 52) of Structure 12. They included, unusually, a complete large mortar of Lincolnshire limestone (531) <494> from pit cg167 (LUB 52); its base had become so thin from use that a large hole developed, rendering the mortar unusable (Fig 8.71). This hole appears to have been produced by pounding, although the undercutting of the inner vessel wall indicates that the mortar was also used for grinding (Mann 1985). Interestingly, the construction levels also yielded large groups of pottery including fineware drinking vessels, jugs, cisterns and pipkins (see above, LUB 50), while among the pottery associated with the complete mortar were the shattered remains of two virtually complete cisterns (see above, cg167 LUB 52). Sherd-links between these LUBs (50 and 52) and Structure 11A, particularly its demolition deposits (LUB 49),

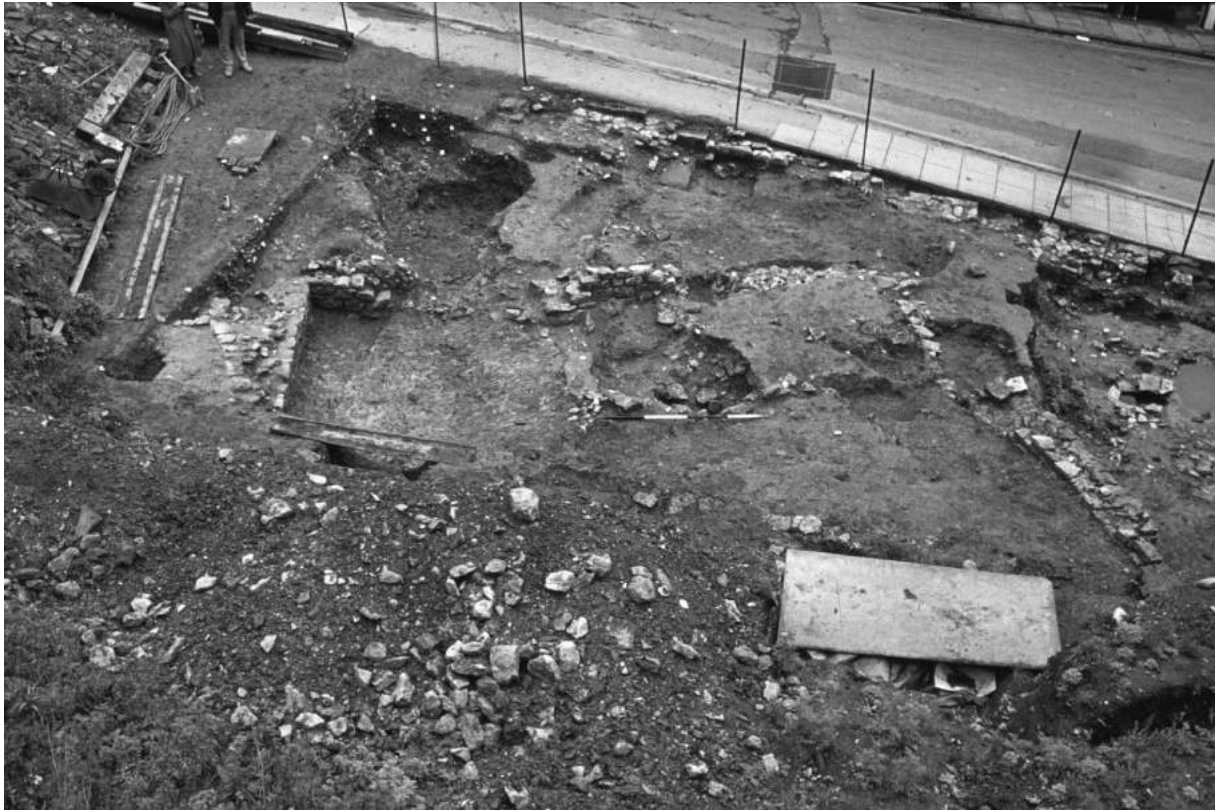
Fig. 9.20. Looking east at Structure 4 (left) and Structure 2 (right): LUBs 3, 4, and 10.

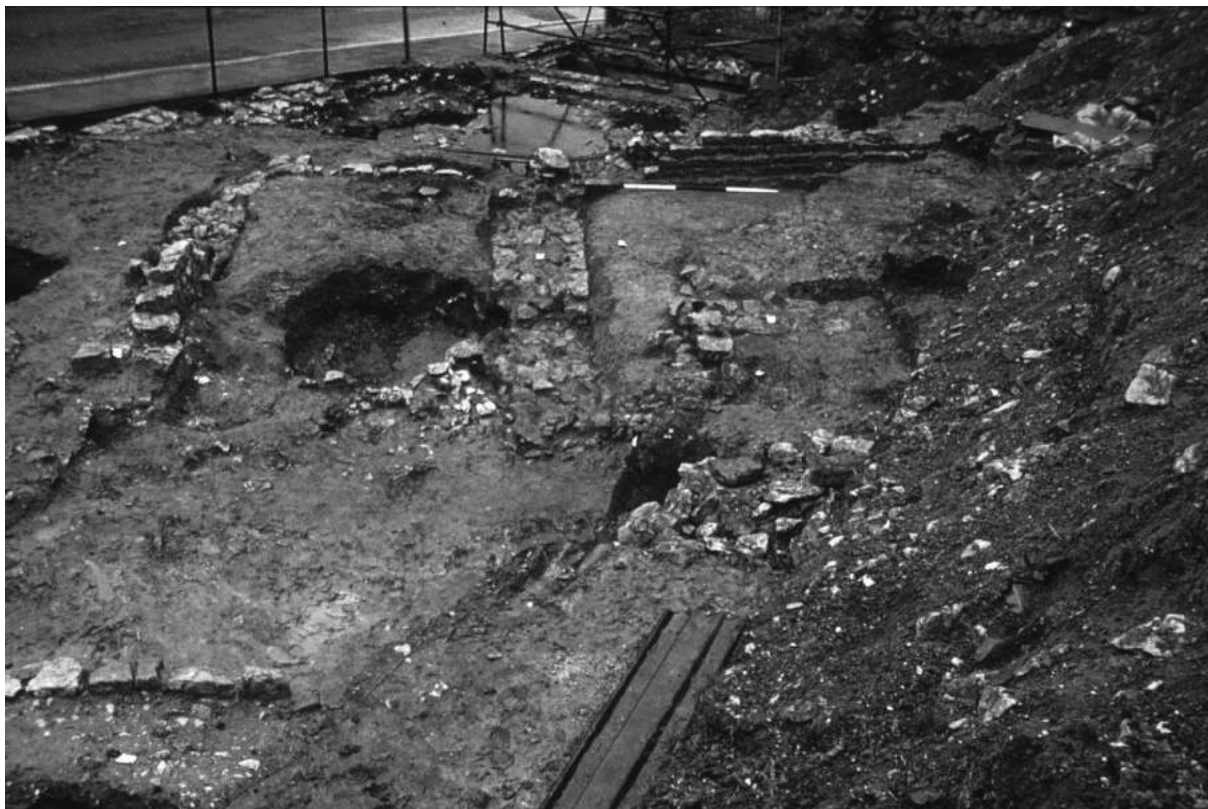
Fig. 9.21. Structure 2: LUBs 3 and 4. Looking south-east.

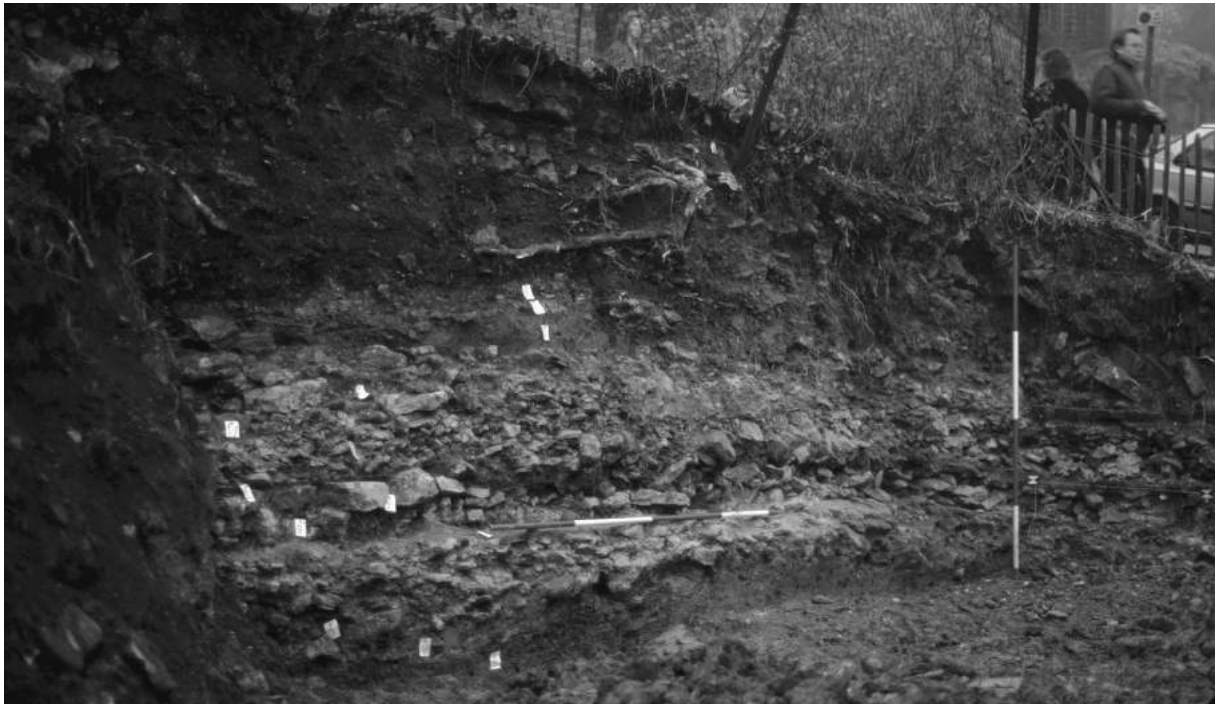
Fig. 9.24. The 1987 section through the Roman street surfaces and overlying dumps at the northern limit of the site: LUBs 6, 7 and 8. Looking north-east.

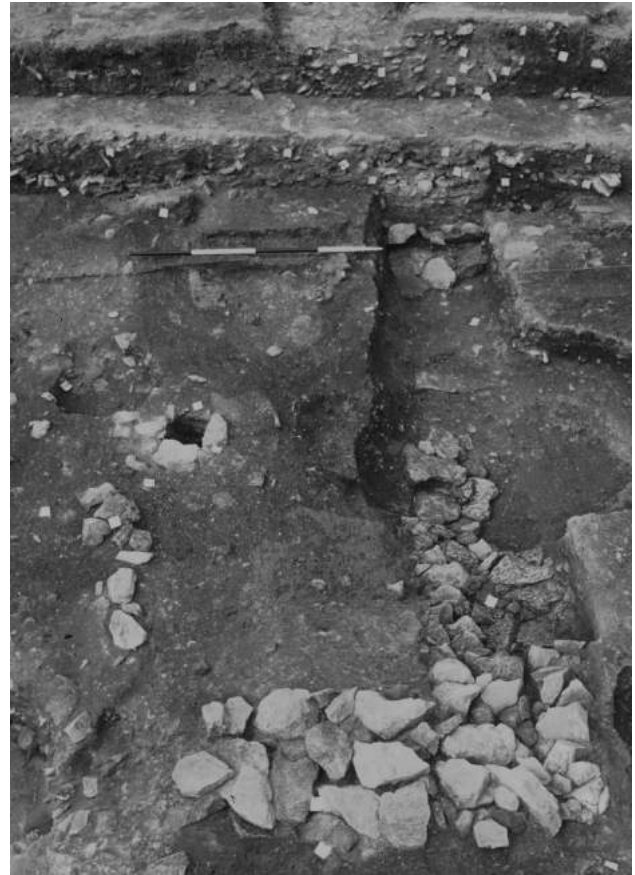
Fig. 9.25. Looking west at the foundations cg46 of Structure 5; to the left of centre is later pit/posthole cg131: LUBs 14 and 48.

Sealing occupation/floor layer cg61 (LUB 15) of Structure 5 was a yellowish-brown silt with limestone fragments cg91 and the slight remains of a terrace retaining wall cg92, which suggest that the former site of the building had been cut by an east–west terrace (Fig. 9.25) and the levelling cg93 which had been dumped over it. Layer cg93 contained much building debris, largely Roman tile and tesserae. Probably equivalent to dump cg93 was a dump of loam with charcoal cg89, cut by a pit cg90; over this was a dump of tile, brick and limestone cg95 sealed by another loam dump cg96.

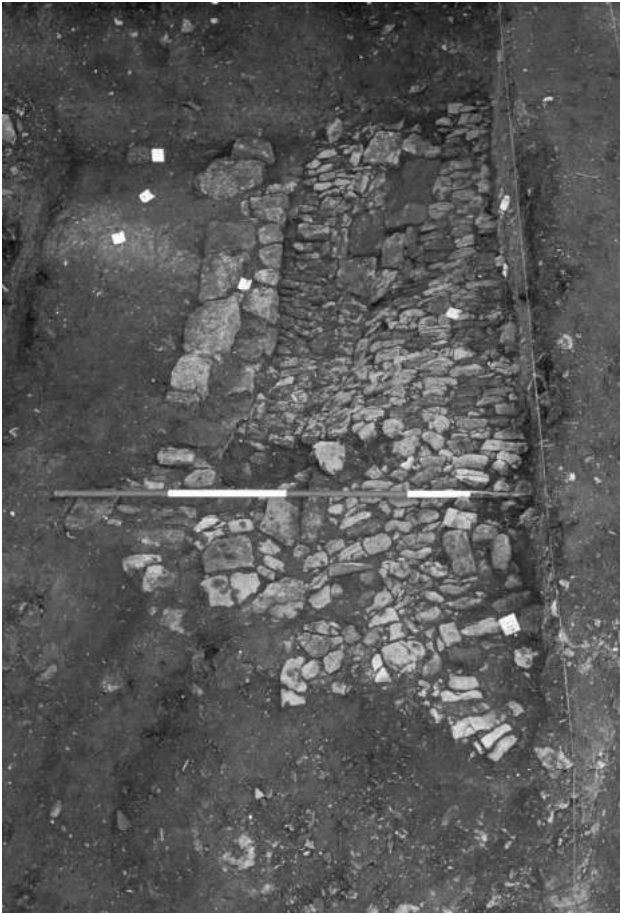
Fig. 9.27. Looking west at surface cg76 in the western extension, with kerb cg79 to the left: LUB 22.

a yard to its south, both of which fronted Steep Hill; there was also a yard or cobbled path to the rear (LUB 22; Fig. 9.27). The only surviving remains of Structure 8 consisted of the garderobe cg153, and fragments of walls to the north of the terraced yard. Several phases of the occupation of this area were investigated. The yard to the south of the building was subsequently encroached on by the rebuilding of the north wall and added buttresses (Structure 8.2, LUB 26). This may imply a complete rebuild. A tiled surface with two stone-lined drains diverted rainwater from a roof and from the higher ground to the west. Later, flagstones were laid across the yard surface, together with a further set of drains (Structure 8.3, LUB 27; Figs 9.28–29), and finally a new north–south wall incorporating a garderobe was set against the west terrace (Structure 8.4, LUB 28; Fig. 9.30). The terraced yard area was abandoned soon afterwards.

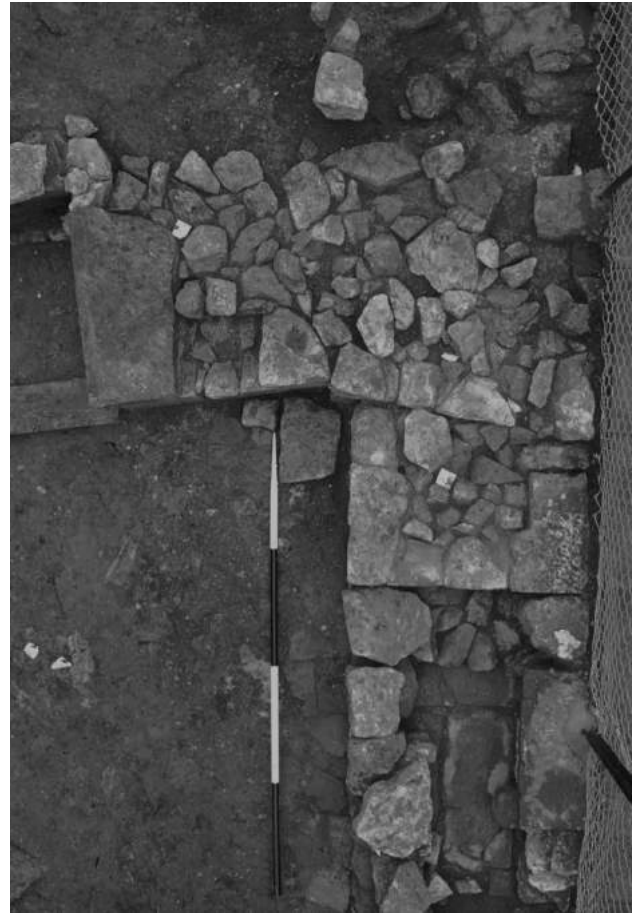
Fig. 9.28. Wall cg204 of Structures 8.2/8.3 (top), at junction with north side of doorway cg118 and blocking cg213 (bottom right): LUBs 26 and 27.

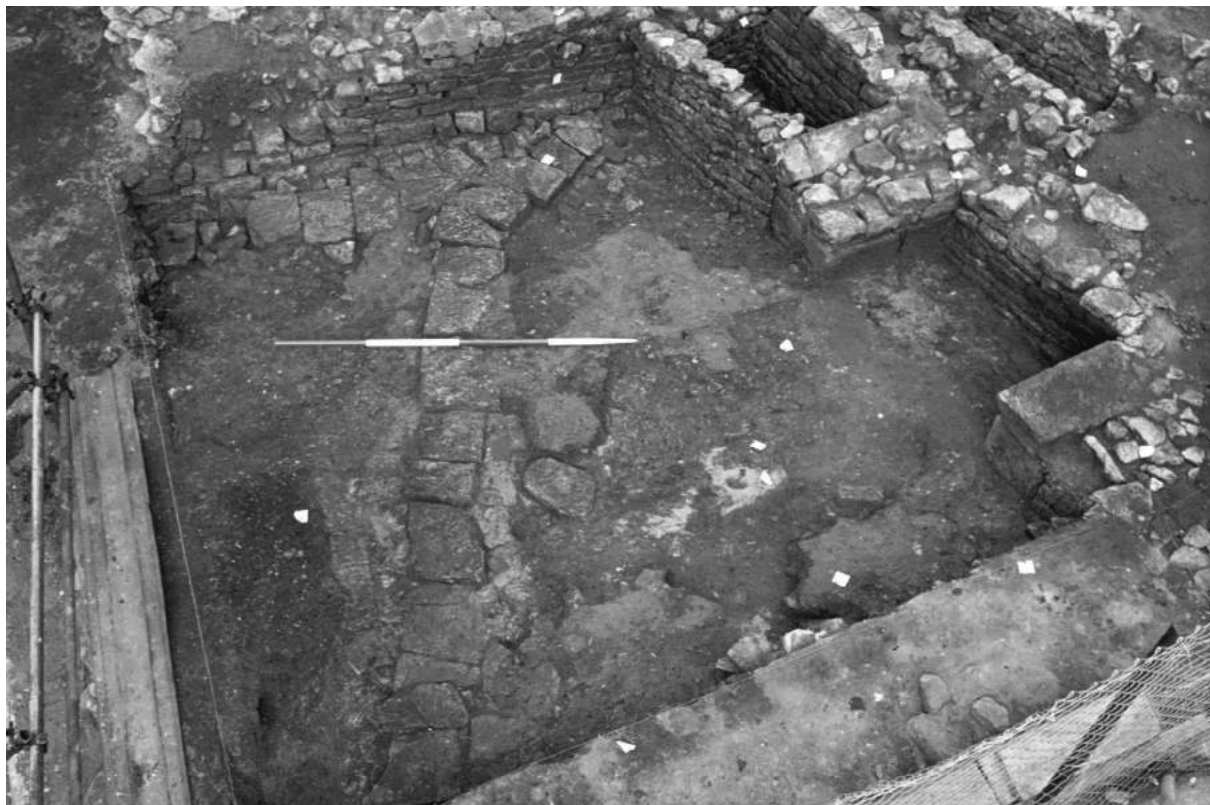
Fig. 9.29. Looking west-north-west at Structure 8.3, drain cg209 across yard and (right) rebuilt east-west wall cg211: LUB 27.

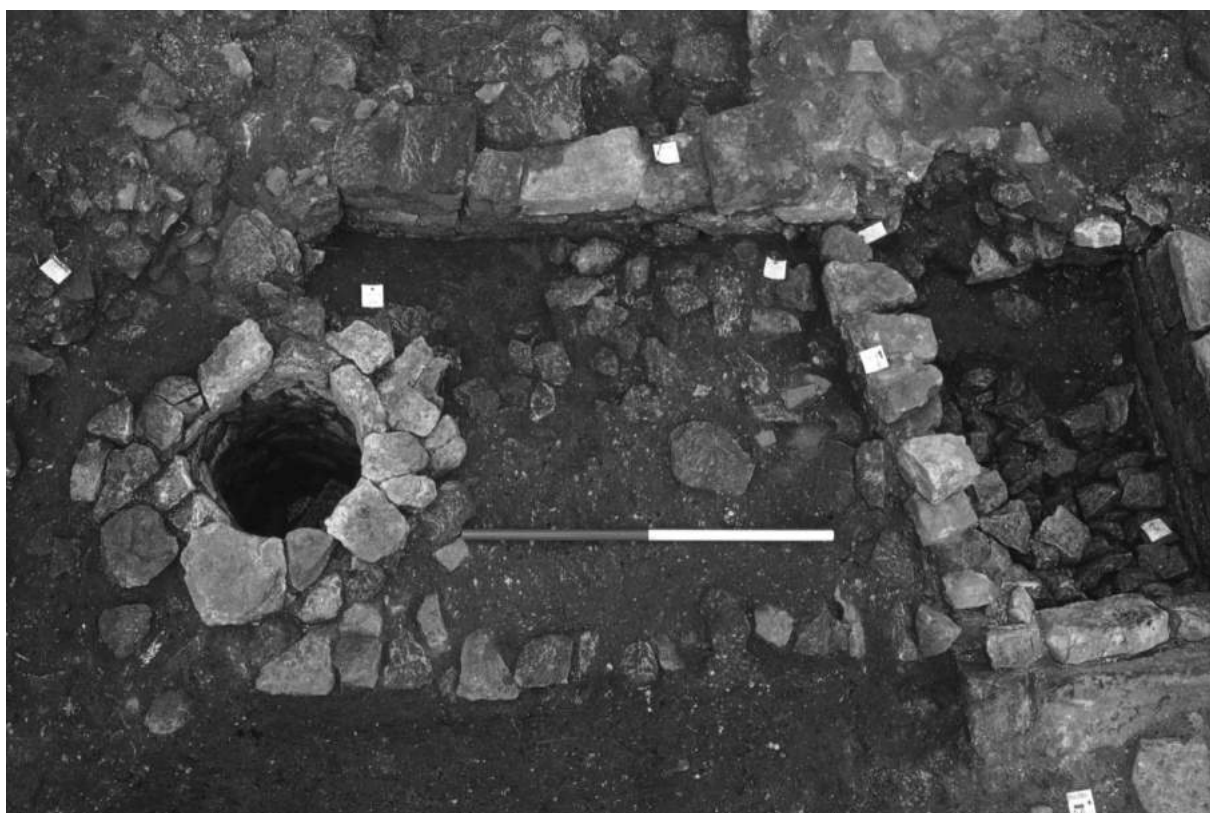
Fig. 9.30. Wall cg223 of Structure 8.4, with inbuilt garderobe: LUB 28. Looking west.

The drains of Structure 8.3 were sealed under a dump of clay cg218, 0.3m thick. Built flush against the west wall cg179 (LUB 20) and sealing clay cg218, was another wall cg223, c 1.3m wide, incorporating a narrow (0.8m in diameter) garderobe (Fig. 9.30).

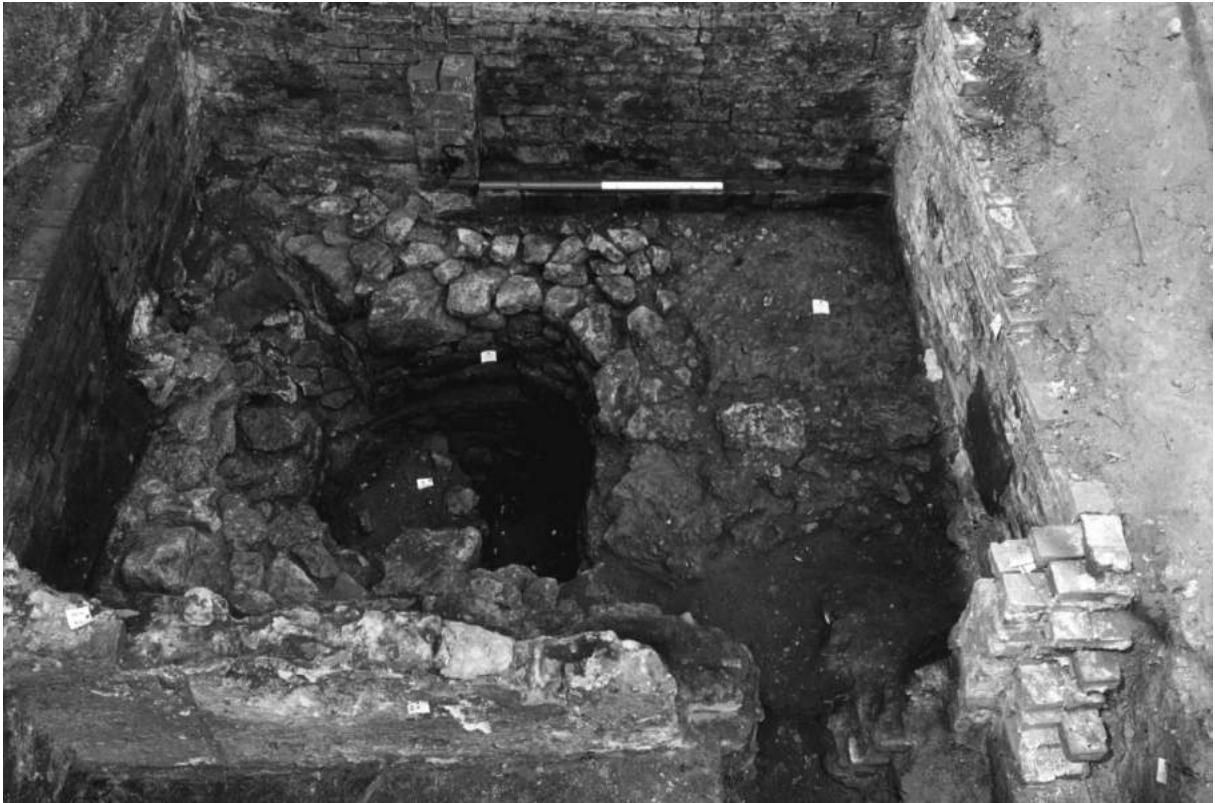
Fig. 9.31. Garderobe cg241 of Structure 9: LUB 32. Looking west.

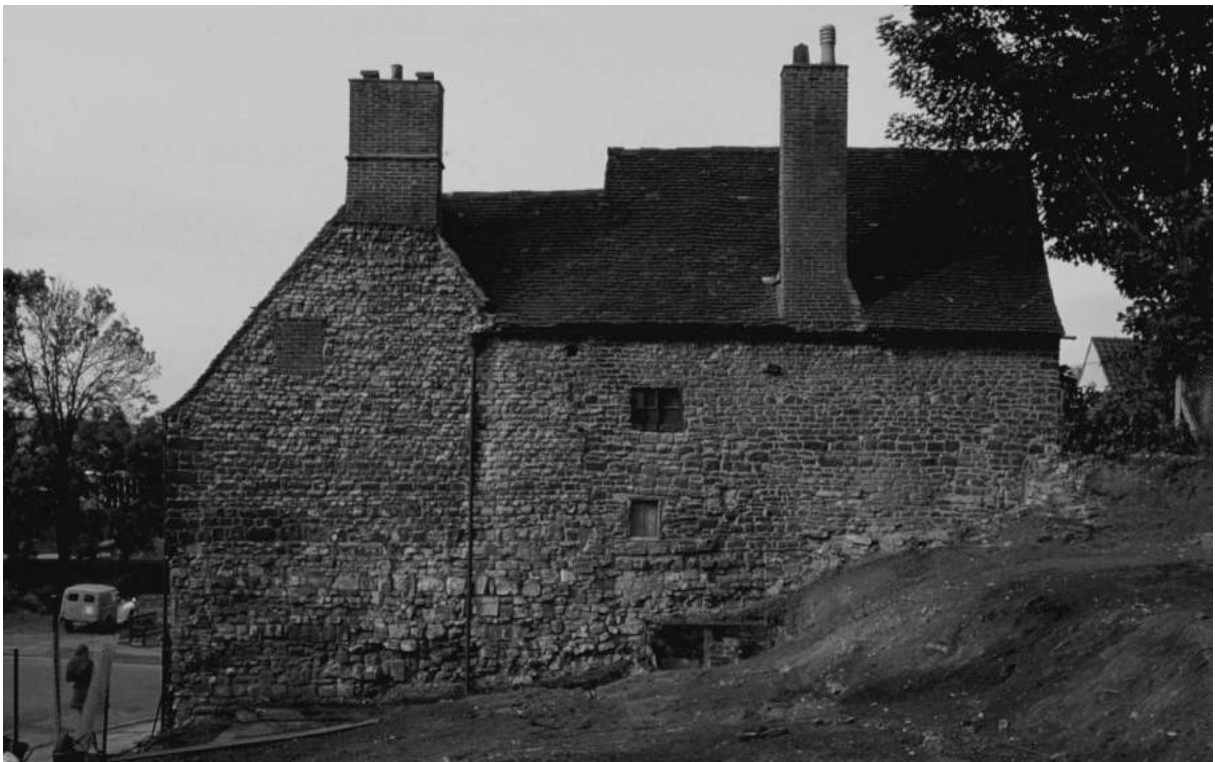
Fig. 9.32. North side of Jews Court, looking south, showing the slope of the hillside from the west down to the east. From a detailed examination of the stonework, the front range of Jews Court seems to have originally been terraced into the hill slope to the north, as indicated by the rough stonework along the lower levels of the building, and the back range rebuilt. This terrace may have been removed by the insertion of Structure 11: LUB 42.

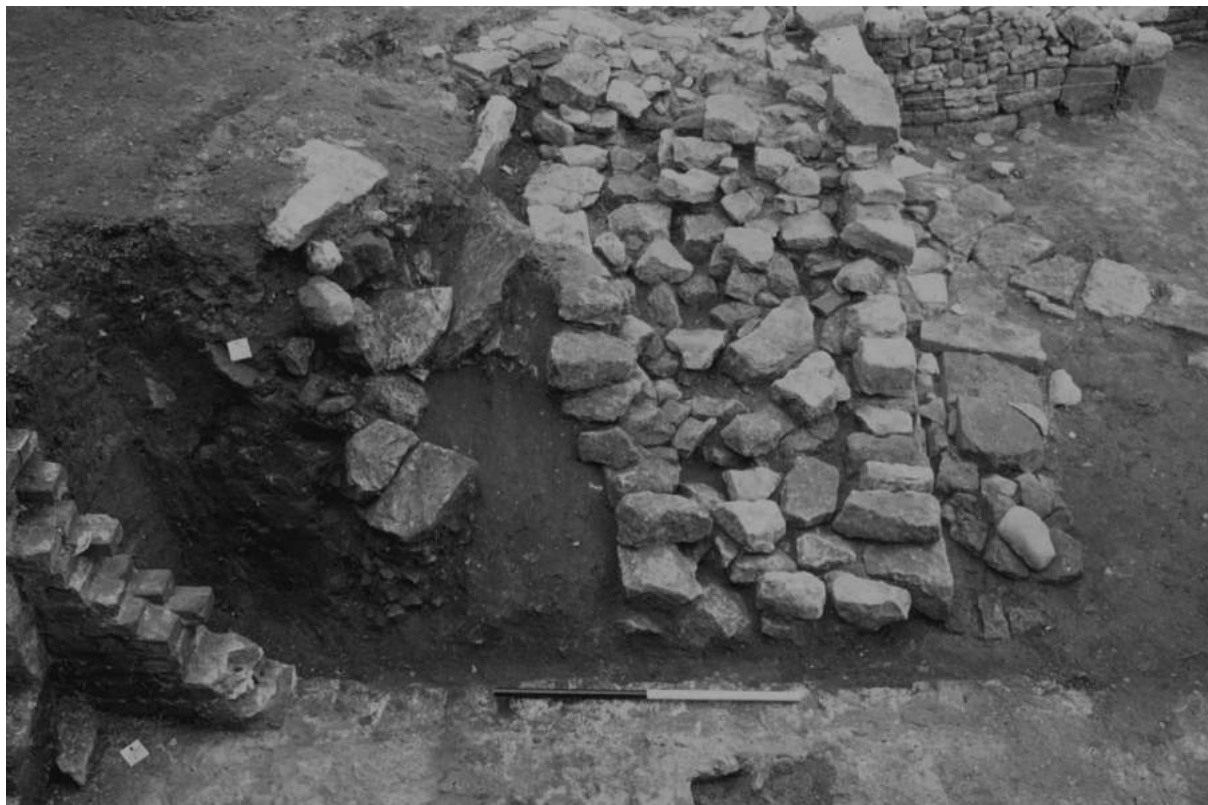
Fig. 9.33. Wall cg179 of Structure 8 cut by Structure 11 (foreground): LUB 42. Looking north.
